ADVANCE REPORT
on the
SEDIMENTATION SURVEY OF LAKE ELDORADO
ELDORADO, KANSAS

April 20 to May 8, 1937

by
Victor H. Jones

Sedimentation Studies
Division of Research
SCS-SS-25
July 1938

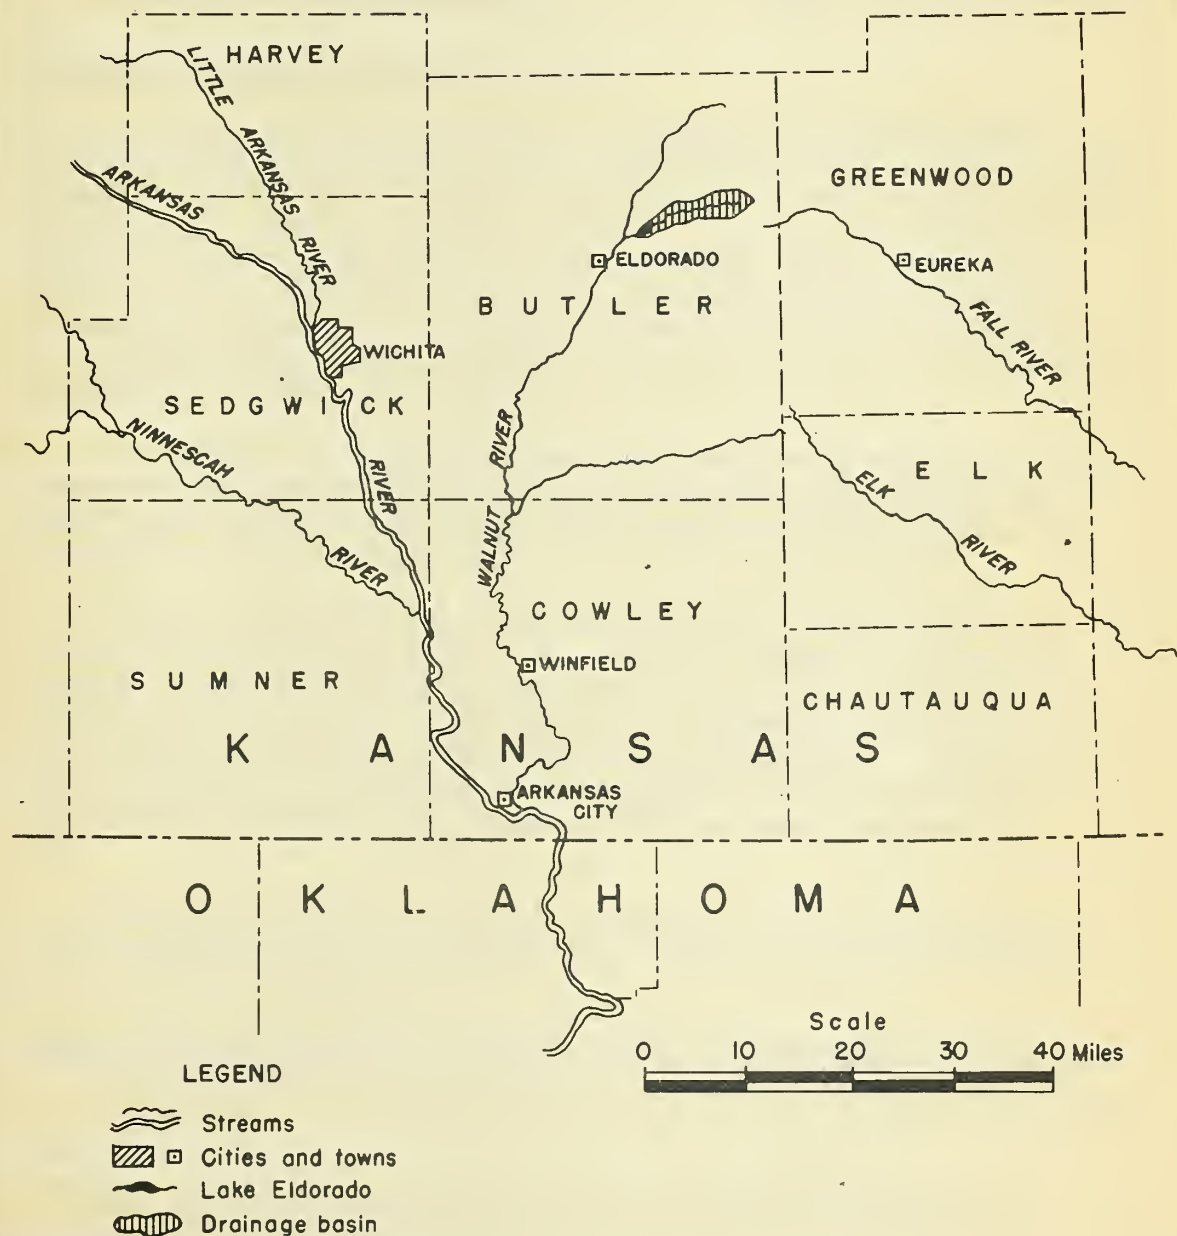
MAP SHOWING LOCATION OF LAKE ELDORADO

Location (fig. 1):

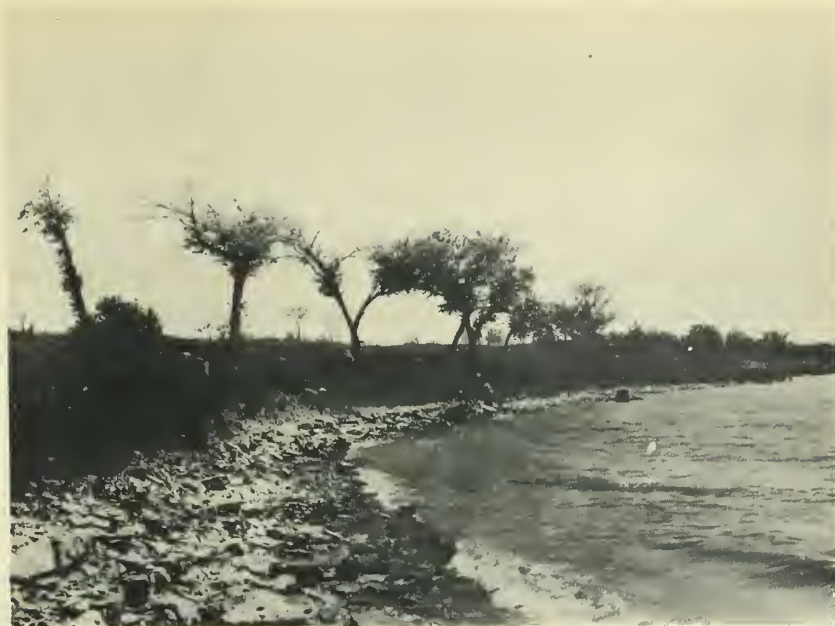
Figure 4.—Thin-bedded limestone on south shore of Lake Eldorado.

The most widespread and conspicuous formation exposed in the area is the Fort Riley limestone, which crops out in the south shore of the reservoir and in adjacent slopes above it (fig. 4). This formation is the key horizon used in the detailed structural mapping of the famous Eldorado oil field, the main producing area of which lies about 7 miles west of the reservoir. Lake Eldorado was built chiefly because salt water from drilling operations had contaminated practically all sources of water for several miles west of Eldorado.

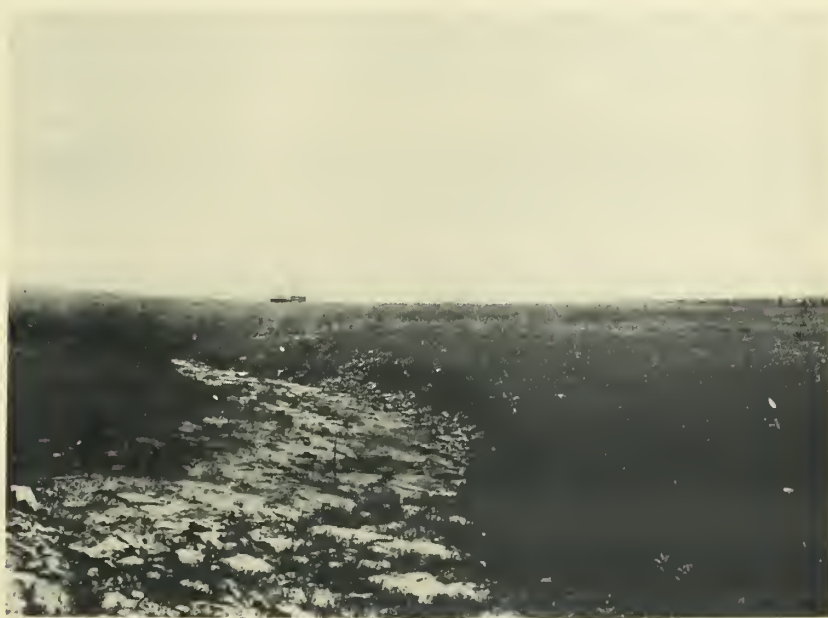
Figure 5.—Typical small gully on the south slope of Satchel Creek valley near Lake Eldorado.

A few small gullies have formed on the steeper valley slopes between the dam and sections 4 and 5, T. 25 S., R. 7 E. Few of the gullies exceed 250 yards in length, 50 feet in width, and 3 feet in depth. When once started on cultivated or overgrazed slopes they grow rapidly headward, but their downward growth is limited by the resistant limestones and impervious shales beneath the soil (fig. 5).
